# Manhole Inspection Summary

Manhole # S15GG1007MH

Insp Date: **3/5/09 9:03 AM**

**Location** Address: **PALL MALL RD ALLEY** Cross Street: **QUANTICO AVE**

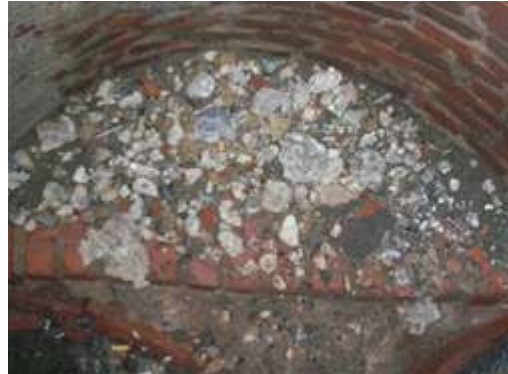
Defect 4

Condition: ☐ Sound ☐ Cracked ☐ Root Intrusion ☐ Deteriorated ☐ Leaks ☒ **Debris**

DEBRIS ON BENCH AND EVIDENCE OF SURCHARGE

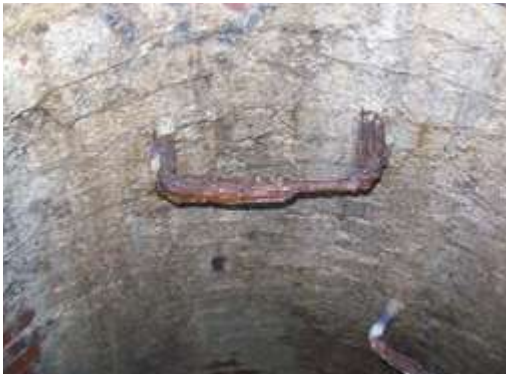
Defect 3

**Steps** Count: **2** Missing: **0** ☒ **Corroded**

CORRODED STEPS

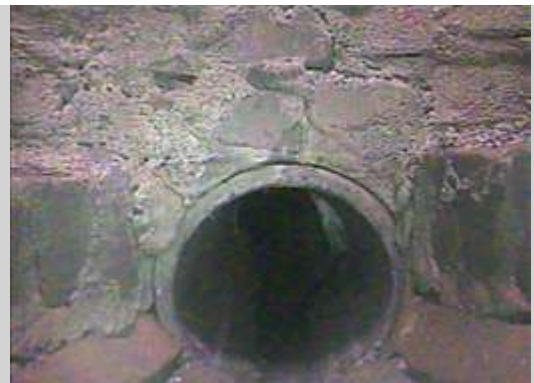
12 O'Clock Outflow

8 in. Circular Gravity Sewer  
Pipe Out @ 12 O'Clock

Infiltration: **None** Pipe Seal Cond: **Sound**

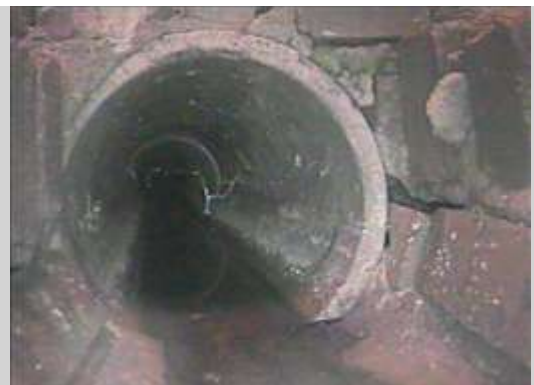
4 O'Clock Inflow

8 in. Circular Gravity Sewer  
Pipe In @ 4 O'Clock

Infiltration: **None** Pipe Seal Cond: **Sound**

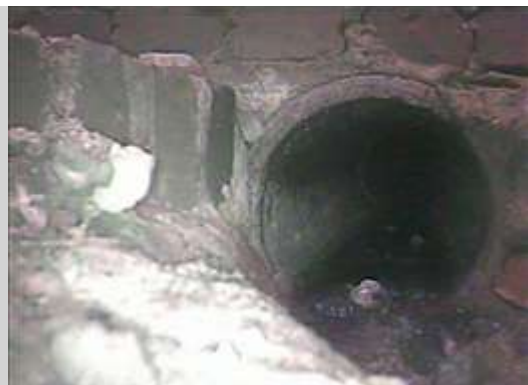
9 O'Clock Inflow

8 in. Circular Gravity Sewer  
Pipe In @ 9 O'Clock

Infiltration: **None**
